EVALUATION OF GABION STRUCTURES IN NORTH RIVER 2521.15 AUGUSTA COUNTY, VIRGINIA DRY RIVER RANGER DISTRICT GEORGE WASHINGTON NATIONAL FOREST

Harold J. Barrett July 1967

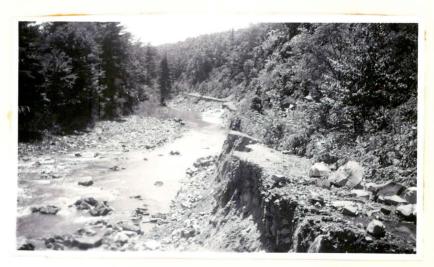
T.T. #95 above the spring box near Girl Scout Camp May Flather. Road washed away. Flood damage 6/17-18/49.

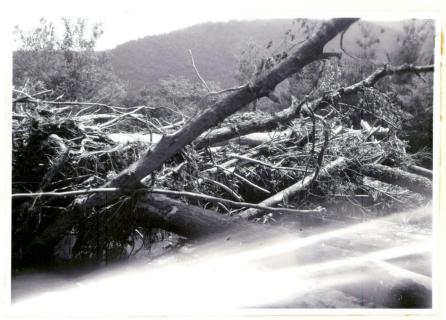
T.T. #95, Bridge #7.3. Debris piled on bridge at Shifflett Fields. Flood damage 6/17-18/49.

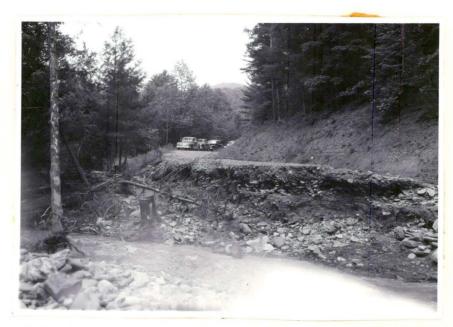
T.T. #95, at Bridge #7.3. Cars of 4-H Club members marooned by flood. Flood damage 6/17-18/49.

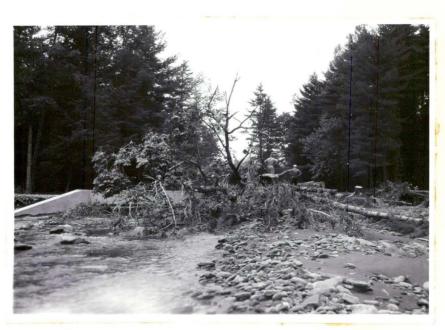
T.T. #95, Bridge #7.3. Shifflett Fields flood damage 6/17-18/49.

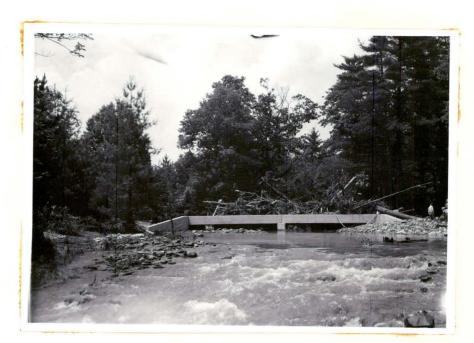
T.T. #95, Bridge #7.3 at Shifflett Fields. Flood damage 6/17-18/49.

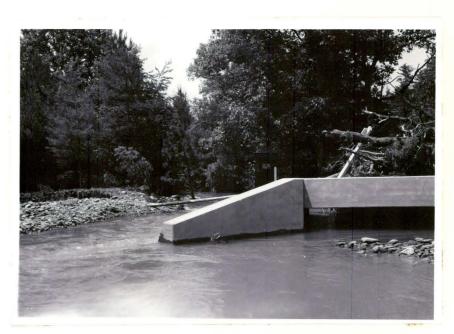
T.T. #95, Bridge #7.3 at Shifflett Fields. Flood damage 6/17-18/49.

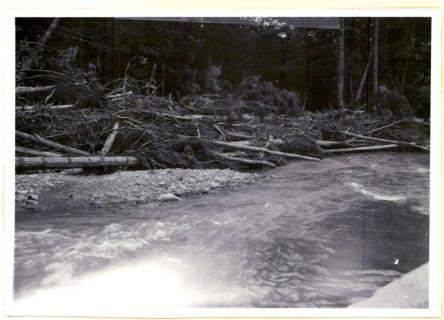
T.T. #95, Bridge #8.0. Debris piled along stream bank. Flood damage 6/17-18/49.

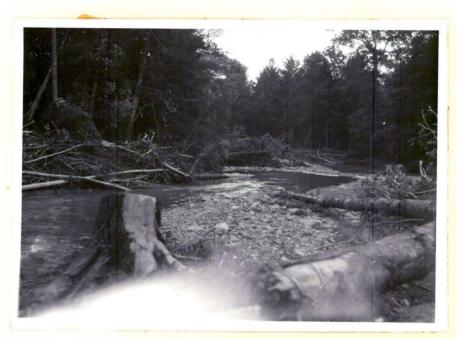
T.T. #95, Bridge #8.0. Stream channel conditions after flood, looking downstream. Flood damage 6/17-18/49.

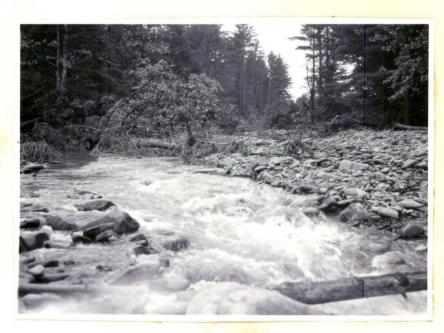
T.T. #95, Bridge #8.0, looking upstream from bridge. Debris and rubble in stream bed. Flood damage 6/17-18/49.

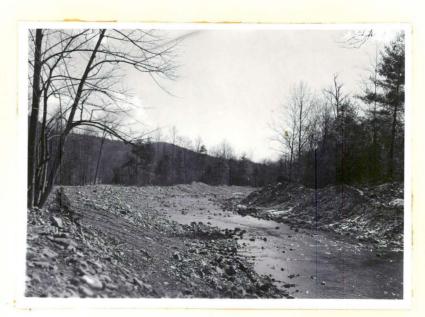
T.T. #95, Bridge #10.3. Channel clearance near Camp Todd after flood of 6/17-18/49.

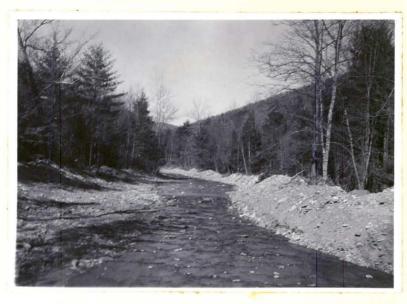
T.T. #95, Bridge #8.0. Channel clearance above intersection of Lebanon Road after flood of 6/17-18/49.

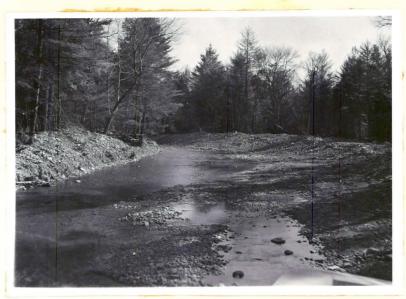
T.T. #95, Bridge #8.0. Channel clearance above Lebanon Road Intersection. Repair work after flood 6/17-18/49.

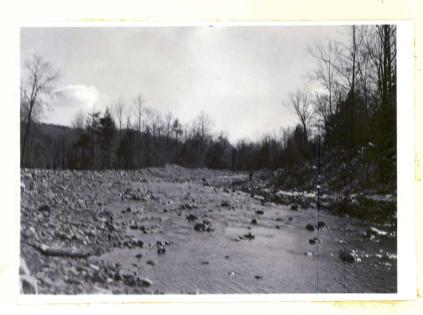
T.T. #95, Bridge #10.3. Channel clearance completed repair work near Camp Todd after flood 6/17-18/49.

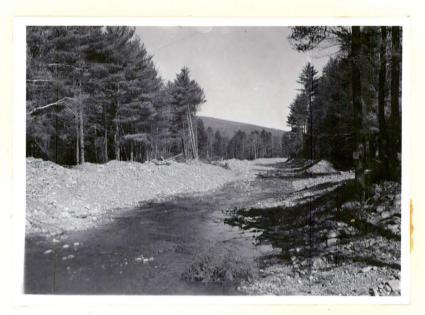
T.T. #95, Bridge #8.0. Channel clearance above Lebanon Road Intersection. Completed repair work of flood 6/17-18/49.

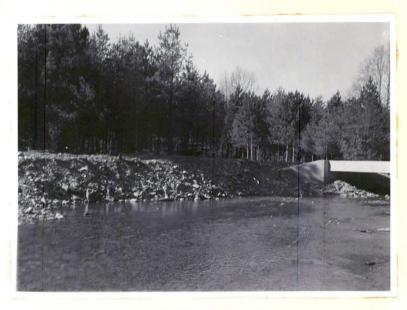
T.T. #95, Bridge #7.3. Completed repair work near Shifflett Fields after flood 6/17-18/49.

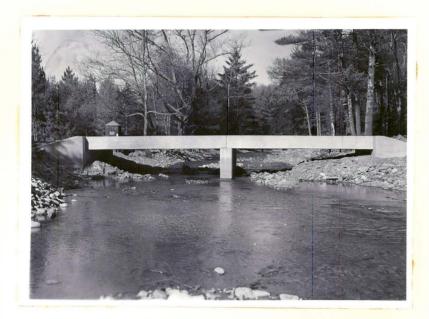
T.T. #95, Bridge #7.3. Completed repair work after flood of 6/17-18/49. At Shifflett Fields.

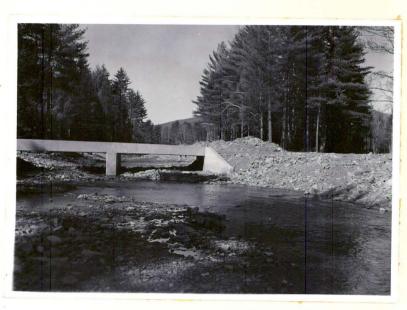
T.T. #95, Bridge #8.0. Above Lebanon Road Intersection. Repair work after flood of 6/17-18/49.

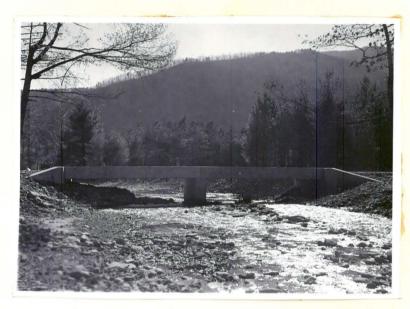
T.T. #95, Bridge #7.3. Completed repair work at Shifflett Fields after flood 6/17-18/49.

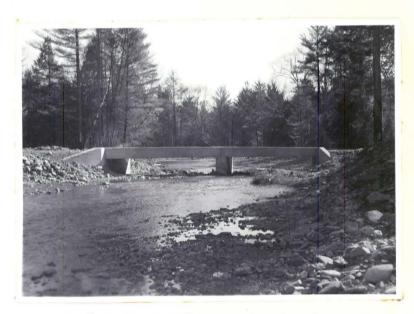
T.T. #95, Bridge #10.3. Completed repair work after flood of 6/17-18/49. Near Camp Todd.

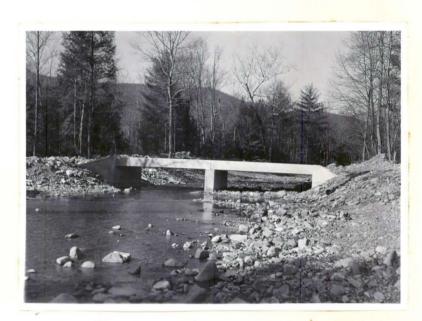
T.T. #95, Bridge #10.3. Completed repair work after flood of 6/17-18/49, near Camp Todd.

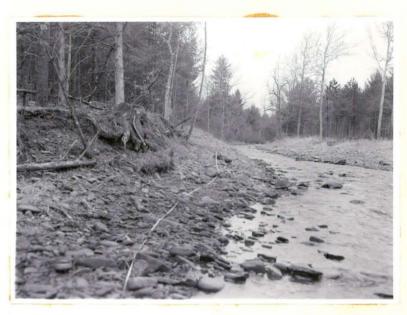
Location of Gabion Wall #26. On left bank 55 ft. downstream from Sta. #312 + 49.

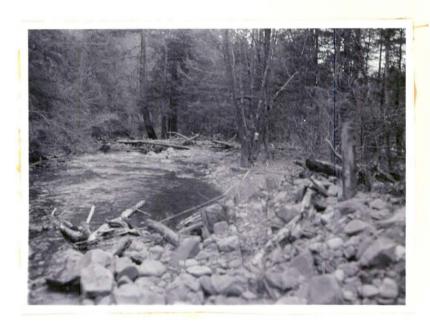
Location of Gabion Wall #28 near Sta. #278 + 73 on right bank.

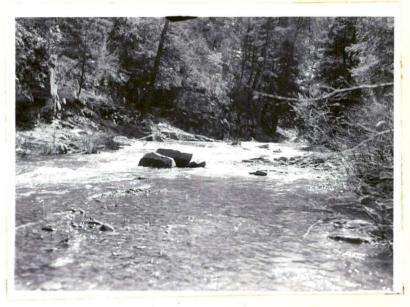
Weir #4, Wall #21 near Camp Todd. Taken looking upstream, 77 ft. downstream from Sta. #341 + 19.
Bank and stream conditions prior to installations.

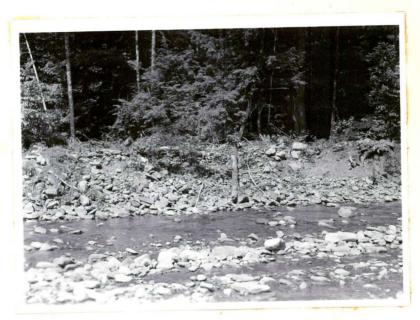
Cross Channel Weir #4 and Wall #21. Picture shows bank conditions.

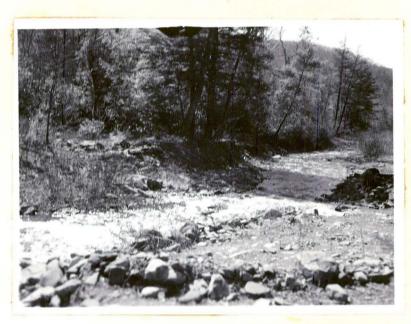
Gabion Wall #2A, near Bridge #13.5, T.T. #95 at the confluence of North River and Big River. Looking downstream, this shows stream and bank conditions prior to gabion installations.

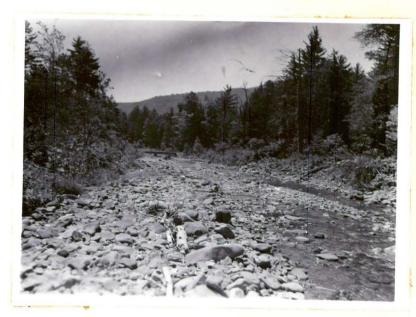
Cross Channel Weir #1, at Sta. #115 + 82. Looking downstream with Bridge #8.0 and T.T. #95 in background.

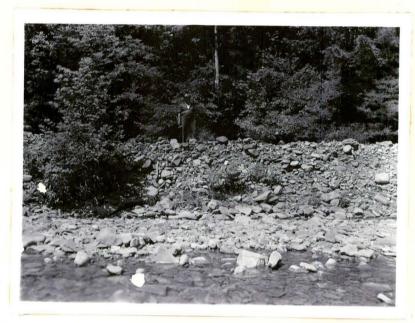
Cross Channel Weir #2 at Sta. #154 + 02, showing the right bank of stream.

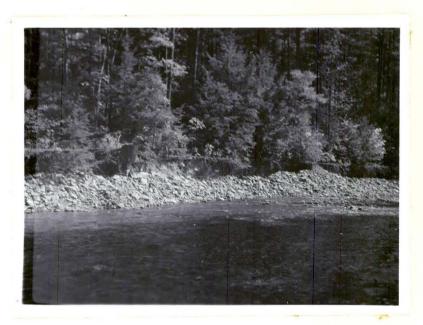
Wall #3, showing condition of bank looking downstream.

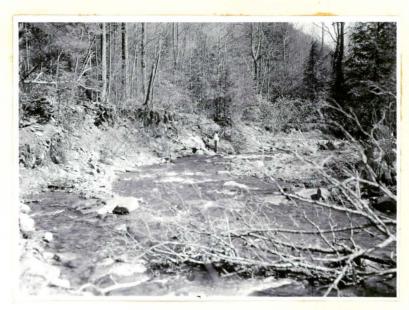
Wall #4A near Bridge #13.0, T.T. #95. Picture taken from bridge looking upstream and shows channel and bank conditions prior to installation.

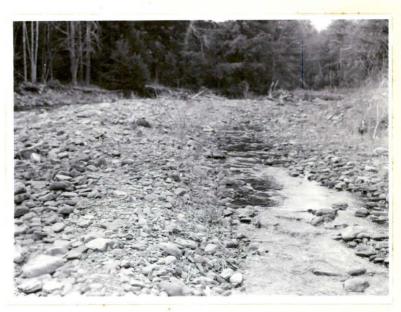
North River - Channel condition prior to dam construction. Below Shifflett Fields at Bridge #7.3, T.T. #95.

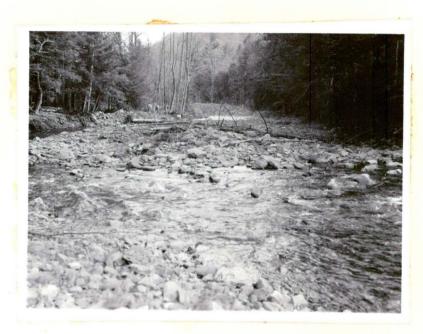
North River below Bridge #7.3, T.T. #95. Channel condition prior to dam construction below Shifflett Fields.

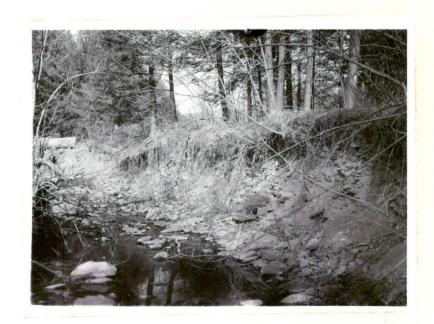
North River below Bridge #7.3, T.T. #95. Bank condition prior to dam construction below Shifflett Fields.

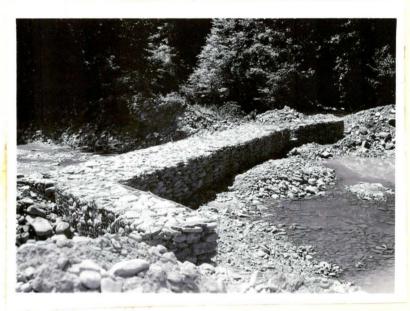
Cross Channel Installation #1 during construction.

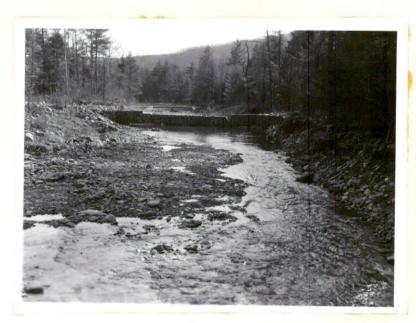
Cross Channel Weir #1 after completion of installation. Bridge #8.0, T.T. #95, in background.

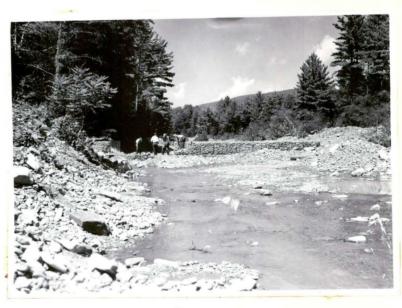
Cross Channel Weir #2 during construction. Picture taken looking upstream.

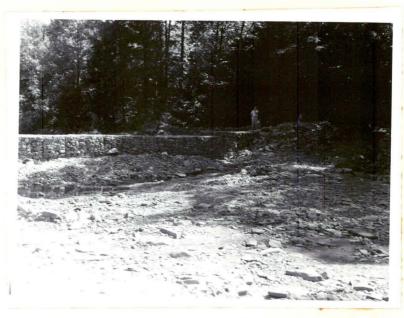
Cross Channel Gabion Weir #3, near Camp Todd. Picture taken during construction of upstream side of weir.

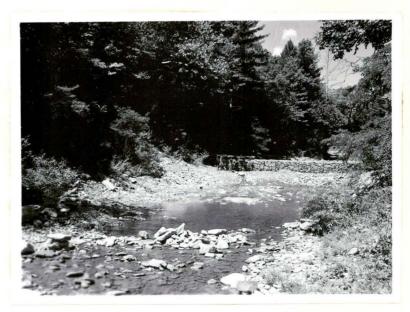
Cross Channel Gabion Weir #3 showing completion of structure. Picture taken from upstream side.

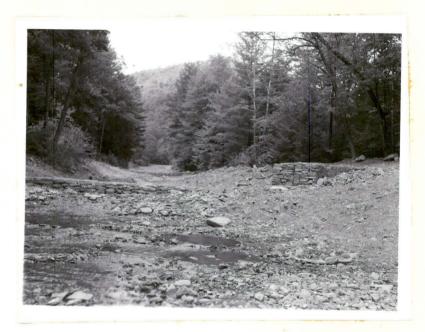
Groin #1, Sill #2. Picture taken looking upstream, 160 ft. south of Sta. #419 + 30. Near head of the river.

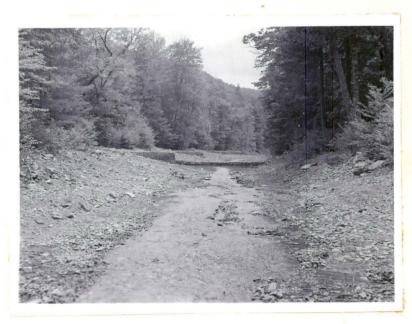
Groin #1, Sill #2. Picture taken looking downstream, 160 ft. south of Sta. #419 + 30, near head of the river.

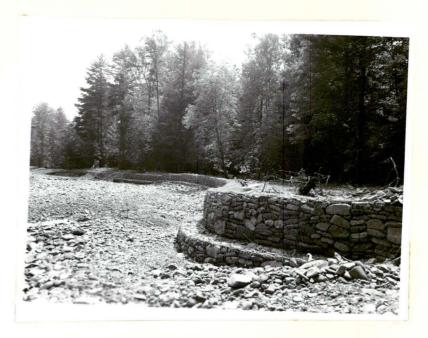
Wall #73, completed. Right bank of stream Sta. # 174 # 18. Picture shows completed structure looking downstream.

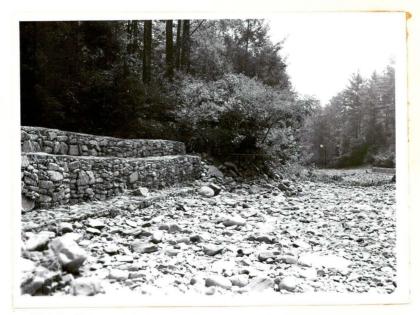
Wall #74. Picture shows completed structure and the end of wall looking downstream.

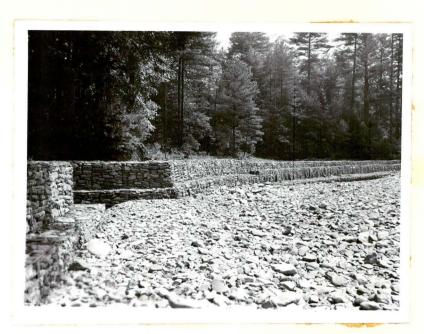
Wall #74. Completed structure on left bank looking downstream. Wing-walls were installed in side channel.

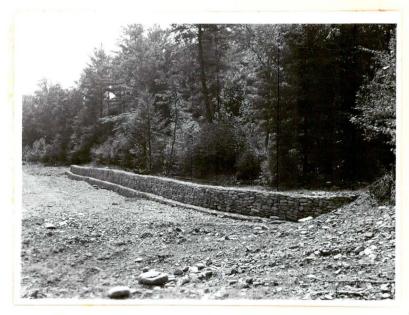
Wall #75. Shows completed structure on right bank looking downstream.

Wall #75. This wall was erected in 1965. The slippage caused in this structure was due to the extension downstream of Wall #74

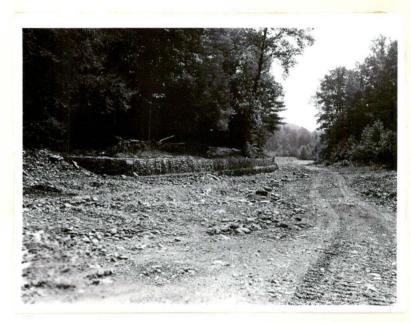
Wall #76. Shows completed structure on left bank looking downstream.

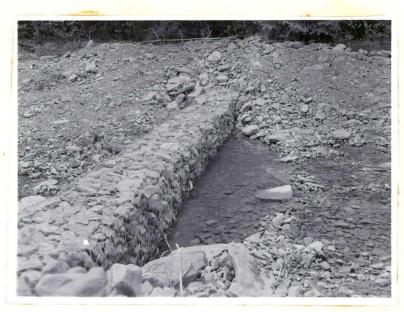
Gabion Sill #1. Picture taken from right bank showing upstream side of sill during construction.

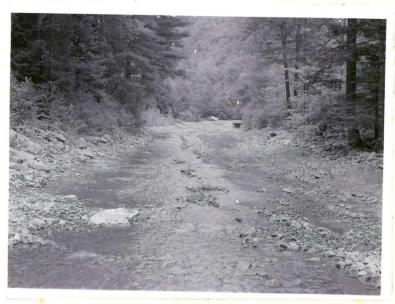
Gabion Sill #1. Picture taken standing in center of CCS #1, looking upstream with T.T. #95, Bridge #13.5 in background.

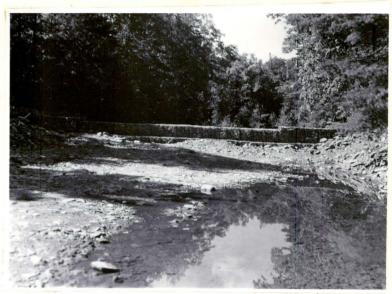
Cross Channel Gabion Weir #4, showing completion of structure. Picture taken from downstream side near Camp Todd.

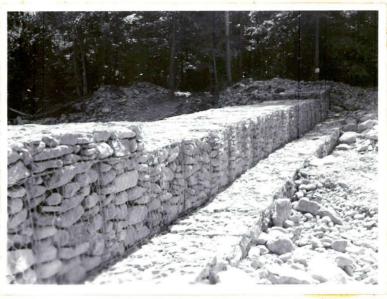
Cross Channel Gabion Weir #3 completed. Picture shows downstream side of structure.

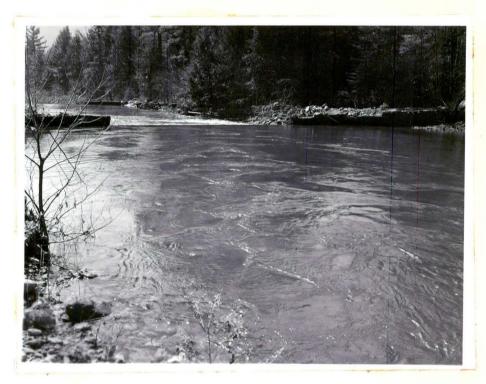
Weir #2 near Bridge #8.0, T.T. #95.

Weir #2. Conditions around Weir #2 above T.T. #95, Bridge #8.0, are depicted in the pictures. On the left bank looking upstream above Weir #2 we find erosion of the bank taking place. To eliminate this problem a wall 10 meters long (32.8 ft.) along the bank and tied to the weir to protect this area from further erosion should be installed.

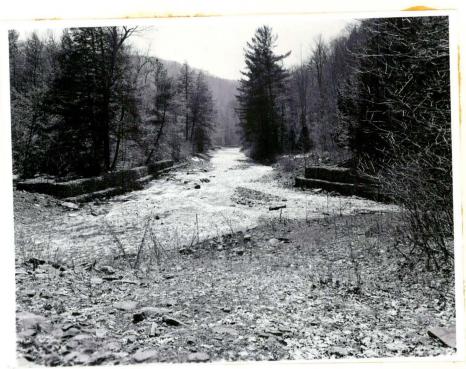
Head of North River. Wall #1A in foreground and Wall #2A in background.

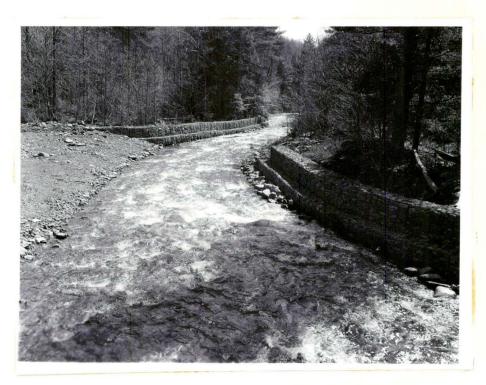
Wall #75 in foreground. Wall #76 in background.

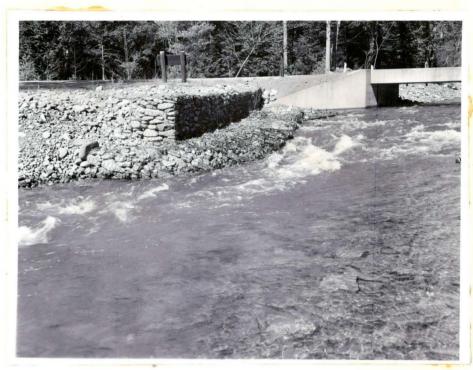
T.T. #95, Bridge #8.0. Completed installation of Gabion #4 for protection of abutment.

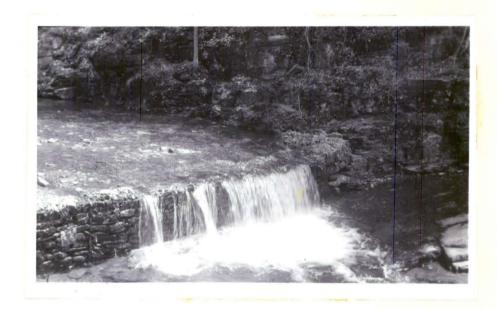
Wall #21 with cross channel weir at Sta. #341 + 19 on T.T. #95 and above Bridge #11.7.

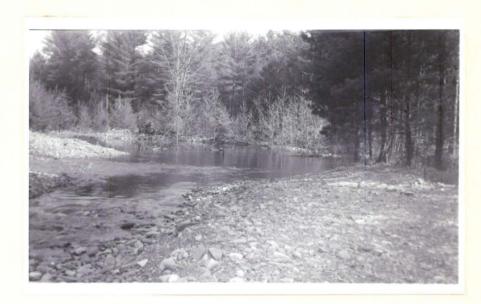
The installation of these weirs were originally for the purpose of retaining the sedimentation that was moving downstream. Their action can be explained as being created for the same purpose as that of a sediment pool. The retardation of this material is essential if we ever anticipate or expect to stabilize channels, reduce gradient and channel velocities. At the same time we are expecting that we will be able to increase the roughness coefficient of the stream. The alternative would be to move this sediment every few years, which is not the answer we are looking for. There is also the possibility of bulldozing this material to each side of the stream channel creating a bank, which was originally done. If however, this alternative is followed it should be borne in mind that to eliminate this material from again entering the stream channel a wall should be introduced to retain the material at the bank.

Sediment in stream and lagoon looking upstream from Weir #2.

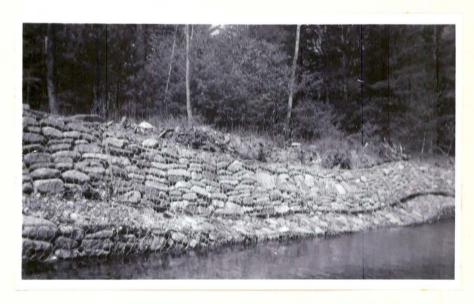
which diverted the stream directly into Wall #75 at this point which was tangent to the stream flow. To correct this problem a revetment meter high and \$8.5 feet long should be placed on top of the present structure in the area where slippage is taking place. At the same time an apron should be placed along the present area where the structure is slipping into the stream. This should be woven to the present structure instead of being tied with the twister.

Wall #75 has slidden out of position.

The material in the channel at the present time should be moved to the right bank and the material at the end of Wall #75 should be moved to the left bank. For complete protection a 100 ft. extension of Wall #74, which was constructed in 1964, should be considered.

At the end of Wall #75 there is an ideal location for a sill I meter high with wing-wall. At the end of Wall #76 there is also an ideal location for a 1 meter high sill to be placed for the retention of rubble and sediment.

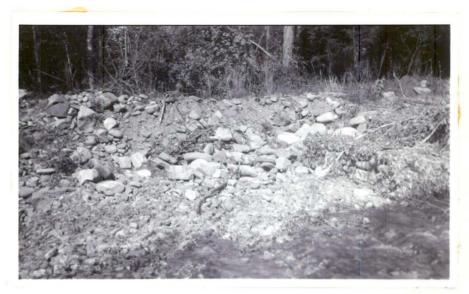
On left bank, looking upstream above Weir #2.

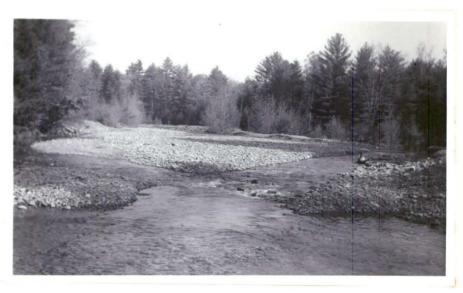
Sediment deposit, looking upstream from Weir #2.

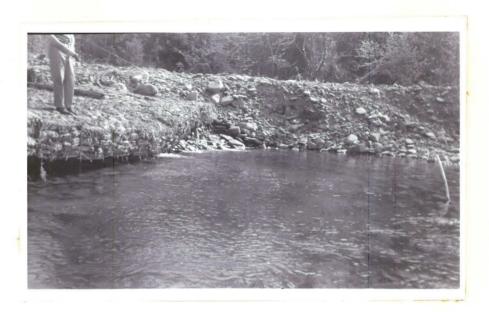
Fisherman standing on apron of Weir #2. This is on left bank looking upstream.

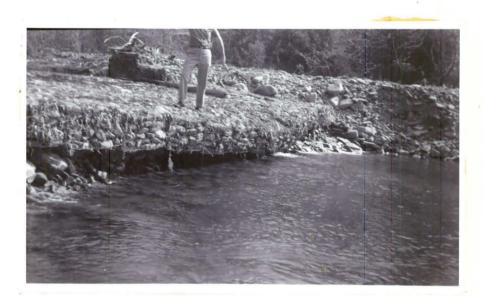
Fisherman on apron of Weir #2. Shows the left bank being cut.

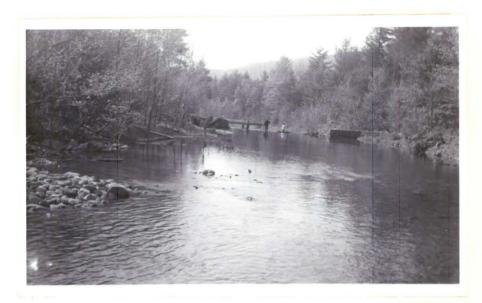
Looking downstream with Weir #2 in background.

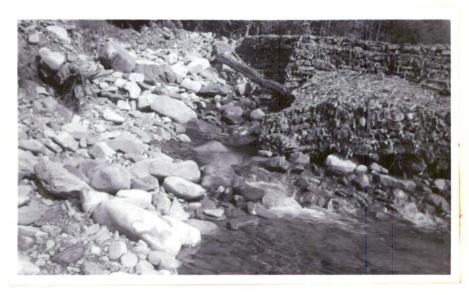
Looking upstream from right bank of Weir #2.

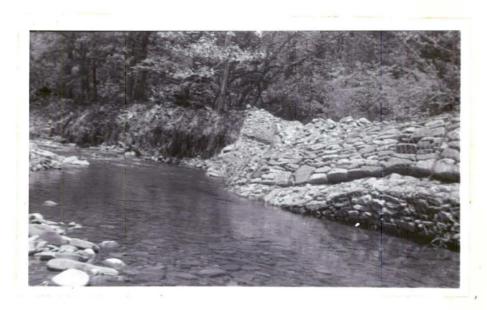
Wall #47 is located on the right bank of the river at Sta. #247 + 41 and extends upstream with the contour of bank a distance of 73 feet. There has been a slippage of the upstream end of the wall and to correct this the wall should be extended 50 feet with a revetment.

Wall #47. This wall was constructed in 1962. It needs an extension upstream of approximately 50 ft. with a revetment of 45 ft. on top of the wall. This extension is approximately 4 meters long.
